12/9/2024

# Executive Summary

# Engineer's Foundation Evaluation

123 Sample Address, Your City, TX, 12345

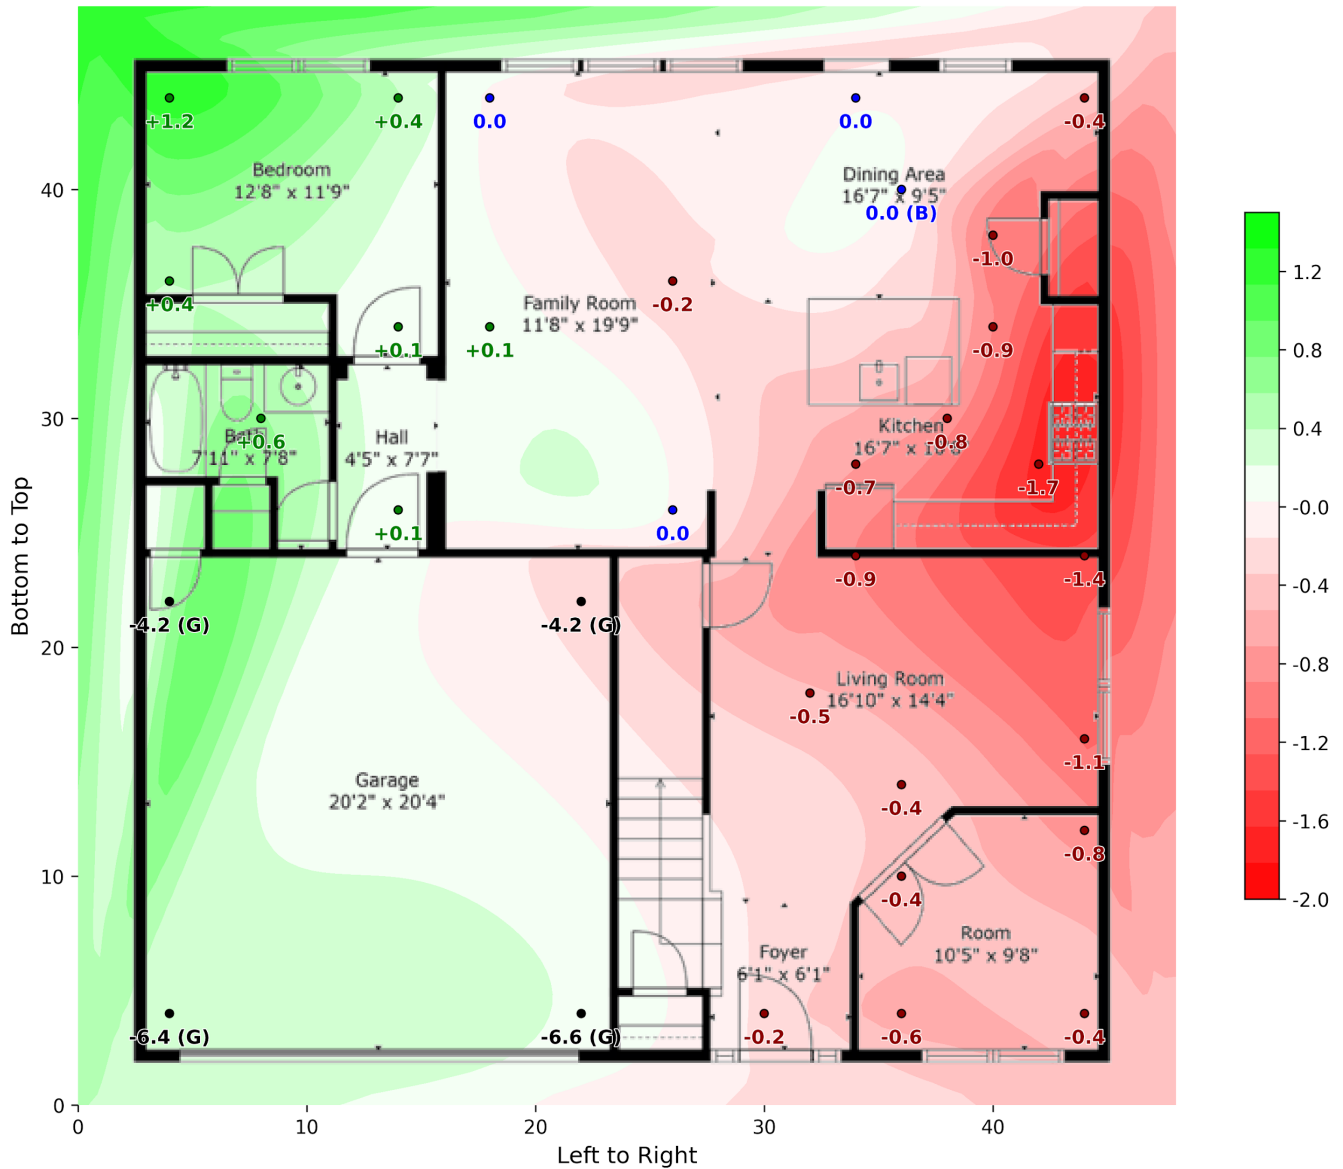
**Elevation Plot Graphic (Figure A)**

The elevation plot resulted in the graphic as depicted above in Figure A. The red-points and areas are elevation measurements that were lower than the base station elevation (0.0). The green-points and areas are elevation measurements that were higher than the base station elevation (0.0). The blue-points (and white areas) are equal to the base station elevation (0.0). The maximum elevation point was determined to be 1.2 inches and the minimum was -1.7 inches, resulting in an elevation difference of 2.9 inches of difference across the structure.

As documented above, the maximum elevation point of this structure was determined to be 1.2 inches and the minimum was -1.7 inches, resulting in an elevation difference of 2.9 inches of difference across the structure. The elevation deflection across an entire structure should remain within 0.5 to 1-inch depending on the age of the structure. Measured differences approaching 2-inches are a sign of foundation fatigue. The maximum allowable elevation difference is subjective, depending on other factors such as the visual condition and age of the structure (19 year(s) old).

Based on observed elevations of the foundation from the elevation plot, the structure cannot be considered fully stable. Elevation differences do not fall within industry standards or tolerable limits. These findings indicate that the foundation does not have consistent and uniform elevation demonstrating continued movement of the foundation.

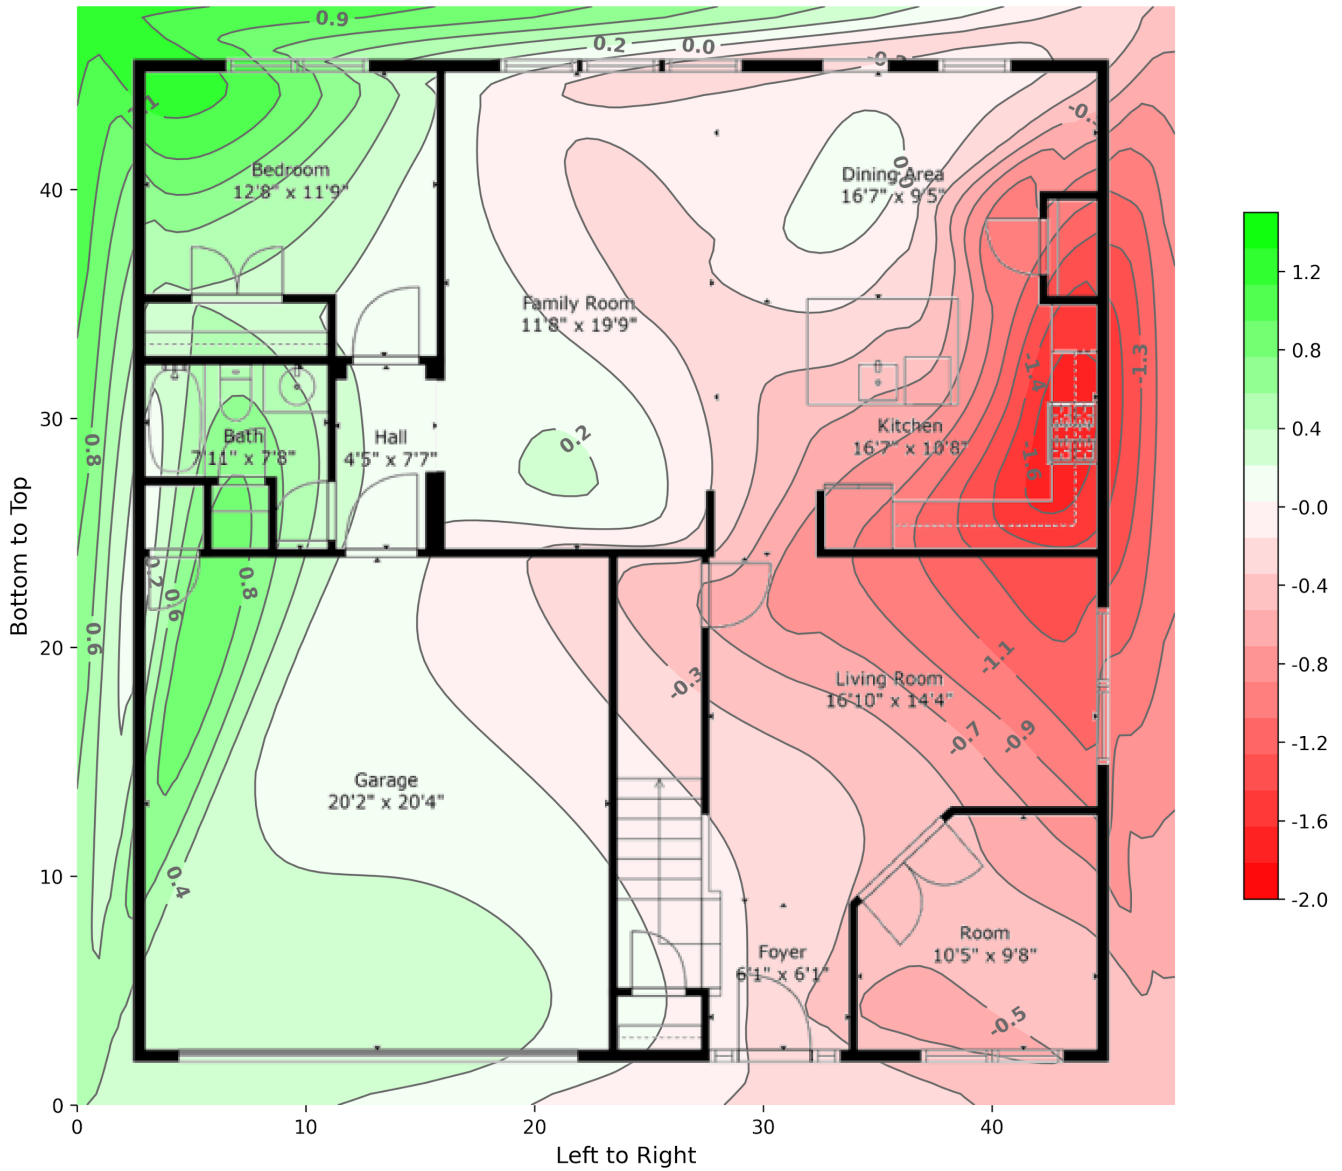
**Mesh Contour Graphic (Figure B)**

The mesh contours graphic depicted above in Figure B is similar to the elevation plot. The red, green, and white areas depict areas that are lower, higher, and equal to the base station elevation (0.0). The contour intervals are labeled.

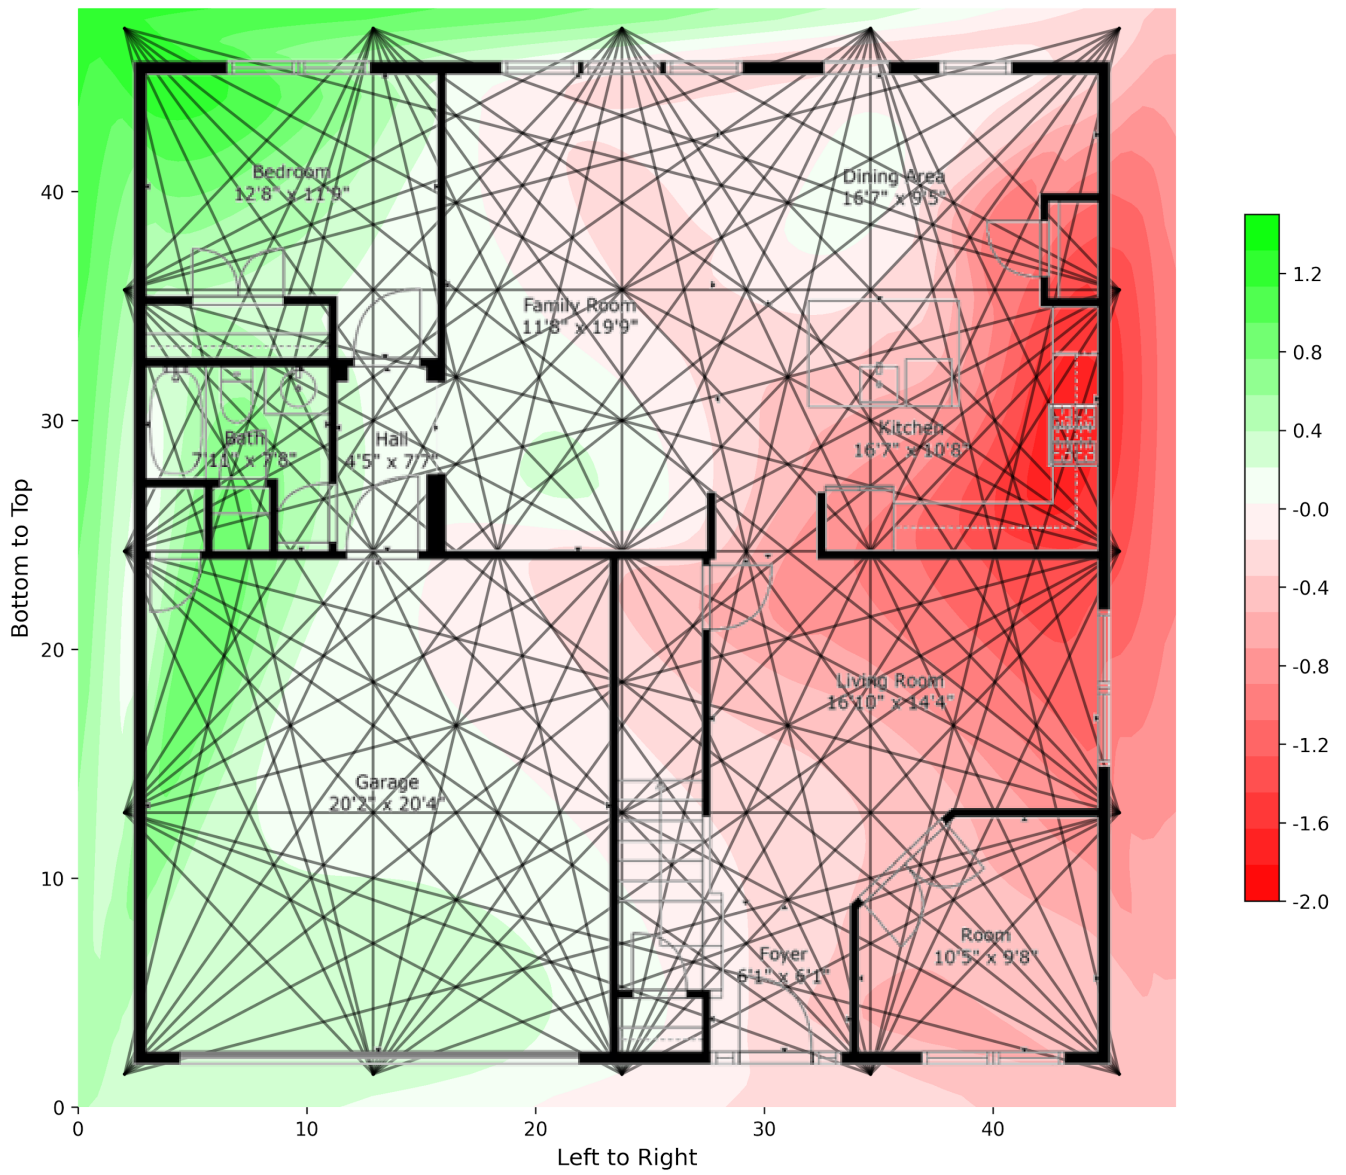
**All Profiles Graphic (Figure C)**

Below is a graphic that shows the locations of deflection and tilt profiles that were calculated. The total profiles calculated was 79 with a total usable profiles (above the effective length threshold) of 76.

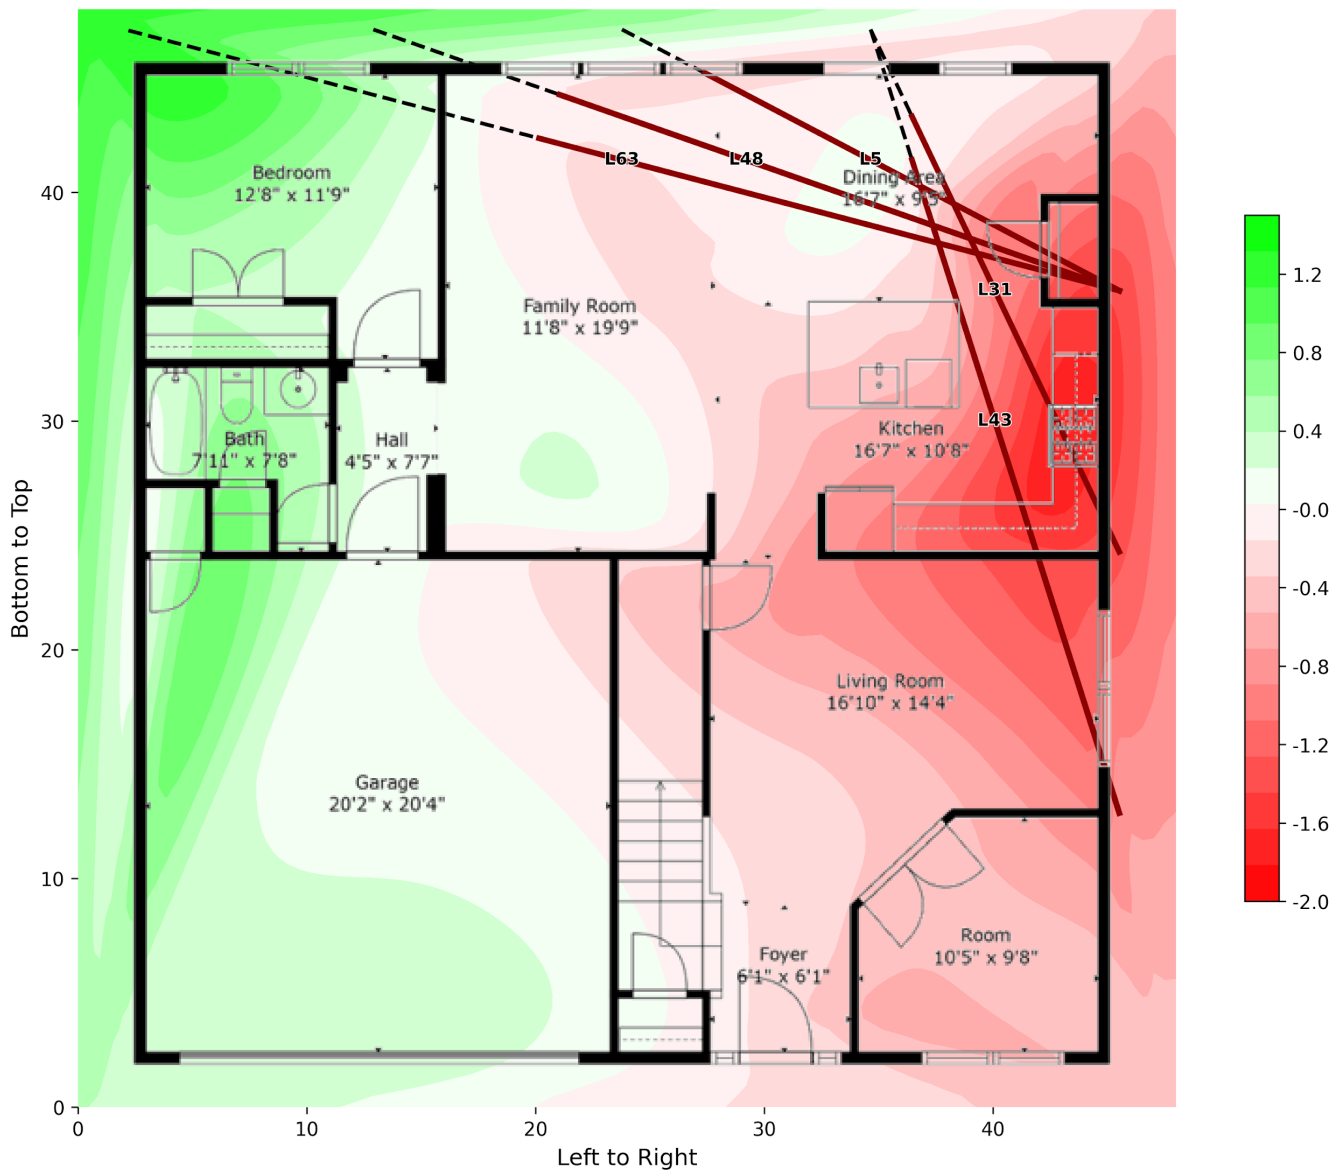
**Deflection Failures Graphic (Figure D)**

The above Figure D shows deflection failures along the foundation. Deflection failures can be considered localized failures in (sometimes) isolated portions of the foundation. The profile lines that were calculated are represented by a dashed black line and the areas that the deflection failures occur are represented by a dark red line segment. Of the 76 deflection profiles calculated, 5 profile failures were identified.

Deflection failures can be considered localized failures of the foundation in (sometimes) isolated portions of the foundation. Of the 76 deflection profiles calculated, 5 failures were identified.

Deflection failures are above standard acceptable limits; they exceed industry-standard thresholds and the structure should be considered actively moving/settling in areas where deflection failures are occurring.

**To stabilize and lift the foundation, install and/or adjust perimeter and interior piles/piers as shown in the attached Exhibit C - Proposed Repair Plan. The underpinning may be concrete cylinders, steel pipe, helical screws, or drilled concrete piers – refer to Exhibits D, E, F, and G. Underpinning will not improve the performance of the foundation in non-underpinned areas. Note, any foundation movement, even corrective, can cause additional cosmetic distress. The contractor shall determine the amount of elevation correction needed based on the reaction of the structure during the adjustment in order to minimize stress and additional cosmetic damages.**

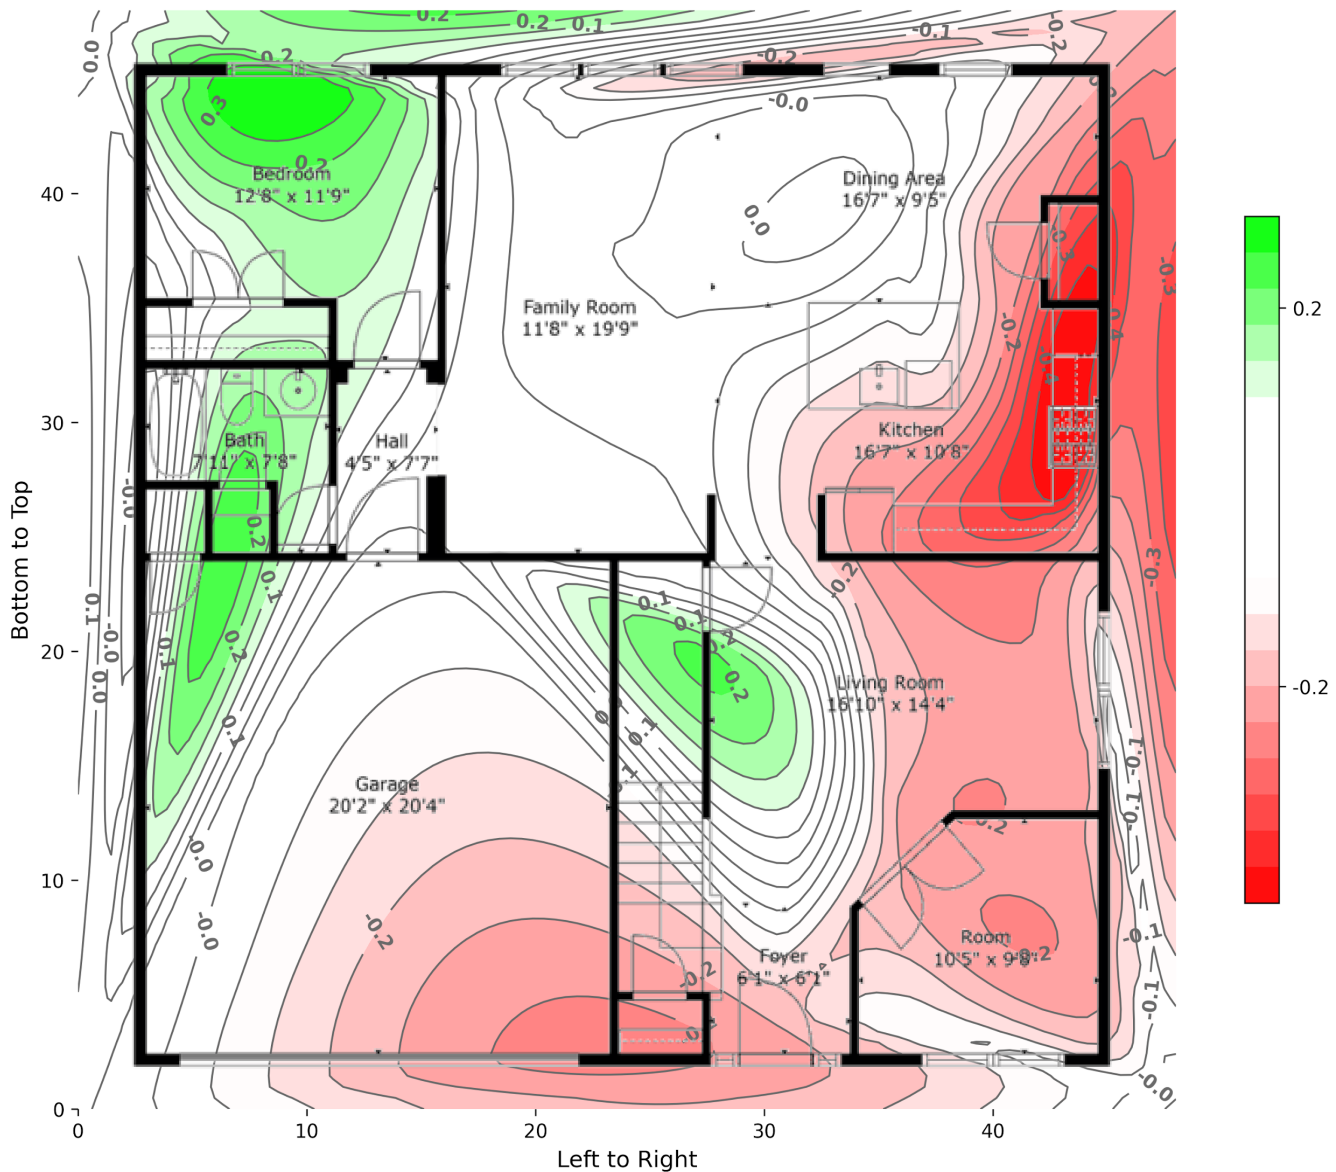
**Elevation Plot Difference Graphic (Figure F)**

A previous elevation plot completed in 1998 was available to use as a baseline of movement progression. As part of this evaluation, a contour mesh showing the elevation differences between the current contour mesh and the baseline was processed and is shown below.

The mesh contour graphic above in Figure F shows areas in red that are lower than the baseline elevation plot and areas of green that are higher than the baseline elevation plot (from the provided drawing completed in 1998). The darker the color (both red and green) the larger/smaller the elevation differences.

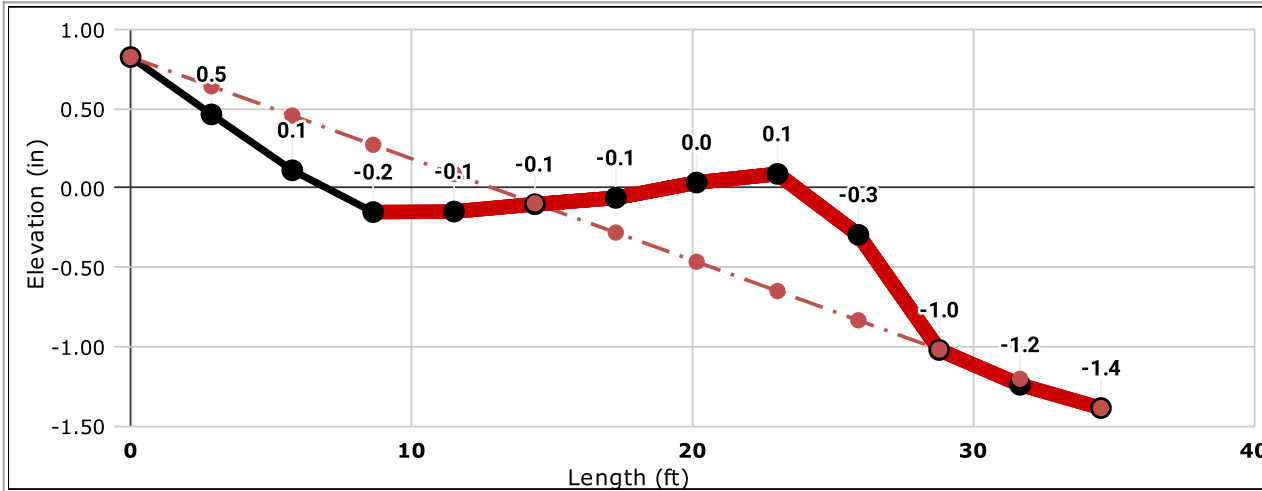
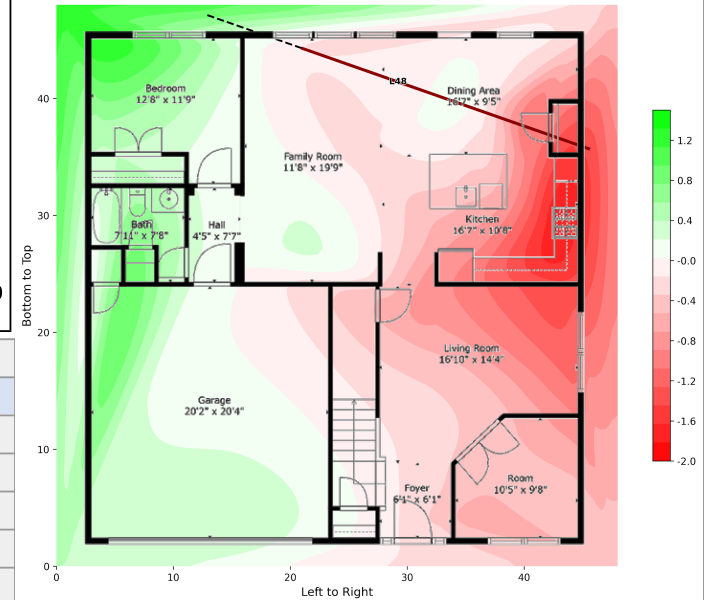
## Exhibit A: Identified Deflection/Tilt Failure (L48)

Performance Output							
Deflection & Tilt	Pass/Fail	Actual		Result Description	Point 1	Point 2	Point 3
Deflection 1 (using k)	FAIL	L /	281	EXCEEDS THE kL/360 (L/340) LIMIT BY 21%	4	9	11
Deflection 2 (using k)	FAIL	L /	281	EXCEEDS THE kL/360 (L/340) LIMIT BY 21%	5	9	12
Deflection 3 (using k)	FAIL	L /	300	EXCEEDS THE kL/360 (L/340) LIMIT BY 13%	4	9	12
Deflection 4 (using k)	FAIL	L /	323	EXCEEDS THE kL/360 (L/340) LIMIT BY 5%	5	9	13
Deflection 5 (using k)	FAIL	L /	326	EXCEEDS THE kL/360 (L/340) LIMIT BY 4%	6	9	13
Tilt	PASS	0.53 %		USING 53% OF THE ALLOWABLE 1% LIMIT
