12/9/2024

# Executive Summary

# Engineer's Foundation Evaluation

123 Sample Address, Your City, TX, 12345

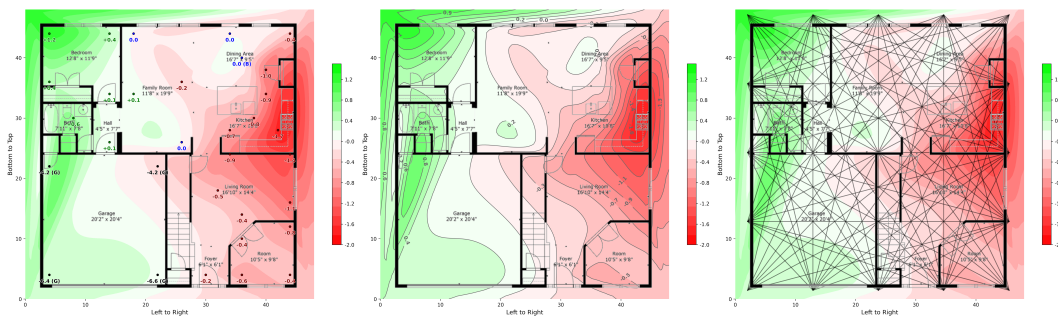
**This evaluation indicates clear signs of foundation issues. Calculations were not found to be within industry standard limits. Remedial measures are required to bring the foundation to a more level condition. It is recommended that foundation stabilization be completed as soon as possible, if possible within the next year. In addition, visual deficiencies noted should be resolved after foundation improvements have been completed. We also recommend you perform another house elevation plot after repairs have been completed to memorialize the elevation changes. Due to the nature that foundation work is recommended, it is imperative that you read the entire report in detail for a comprehensive explanation of this conclusion.**
